TIGER TIPS

A PRIMER ON CABLE DAMAGE AND RELATED FAILURE OF TIGER BRAND MINING CABLES

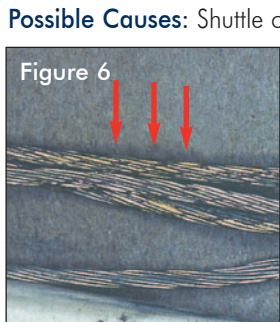
Condition: Excessive tension many times manifests itself rapidly, as shown in Figure 5. Other times it is hidden. When cables are operated somewhat above manufacturers' limits, the flexible stranded power conductor's start a fatigue process of high wear at intimate points of contact. This is particularly true where the center bunch's outer wires intersect the six-bunch layer's inner individual wires. Under normal tension and wear, a little "dust" is the by-product. Under higher tension, "notching" occurs, as shown in Figure 6. Individual wires literally abrade in two against each other. Once several wires fatigue-break, the ends continue to flex against surrounding wires and an exponential growth rate of broken wires results.

Possible Causes: Shuttle car reel tensioning is the single biggest cause. When the cable does not want to rise up off of wet mine floors, operators increase tension on the reel. For drag cables, expediency precipitates long lengths being dragged.

Corrective Action: Keep the shuttle car reel set so that 15 to 20 feet of cable is suspended between the shuttle car and the mine floor during reeling and de-reeling. Keep the tie-point back in a

crosscut and not in the main haulage way. This spreads the tension of the "dynamic reel reverse" over 15 to 20 feet of cable instead of 3 to 4 feet. When dragging cable, a rule-of-thumb is to not exceed 200 feet when pulling by one rope or sling. Add extra slings and pull the cable up in loops of 200 feet.
