TIGER TIPS

Mold-cured Rubber Jackets VS Continuous Vulcanized (CV) Jackets for Mining Applications

Third-party Test Results

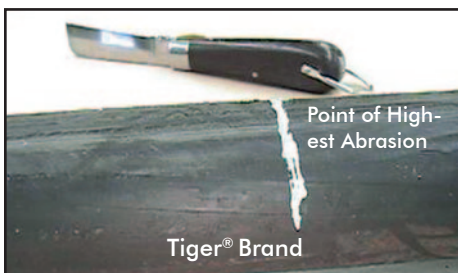
■ Tiger® Brand

Virtually no abrasion on jacket after 15,000 Cycles

The Tiger® Brand mold-cured jacket showed virtually no abrasion at the conclusion of the 15,000 cycle test

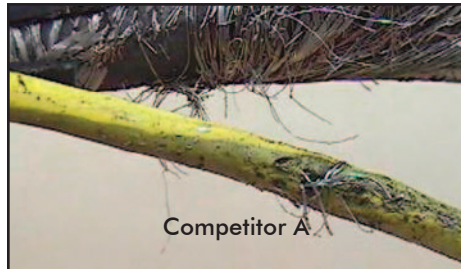
■ Competitor A

Uses soft EP rubber on GC wire. This allows rapid fatigue and penetration of the insulation (2500 cycles).

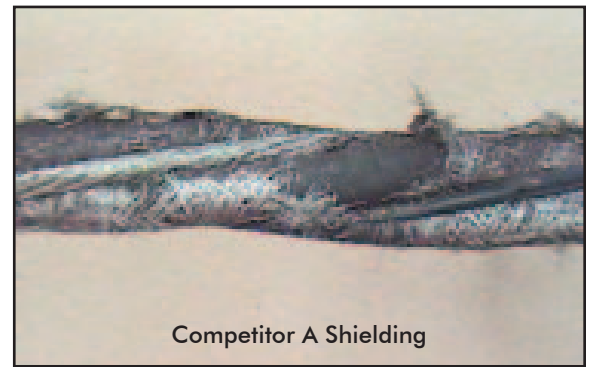
- Competitor A – Herringbone strand opened up and destroyed the shielding, caused wear on insulation and subsequent DC Hipot failures on two-phase conductors and GC. This failure occurred at 2,500 cycles. (see photo)
- Competitor B – Test terminated after 4,715 cycles due to ground check failure. Electrical test (IR) on EP insulated power conductors was low even at this point.

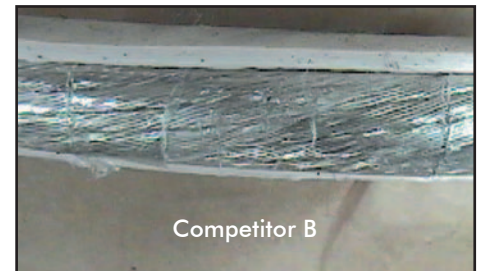
■ Competitor B

Unidirectional strand de-cables under tension.

Note: Power conductor de-cabling leads to early failure of other components in the cable.
